SITE ASSESSMENT REPORT
FOR
CARTER WHITE LEAD
Chicago, Cook County, Illinois
SSID: None

TDD: T05-9307-006
PAN: EIL0267SAA

DECEMBER 29, 1993

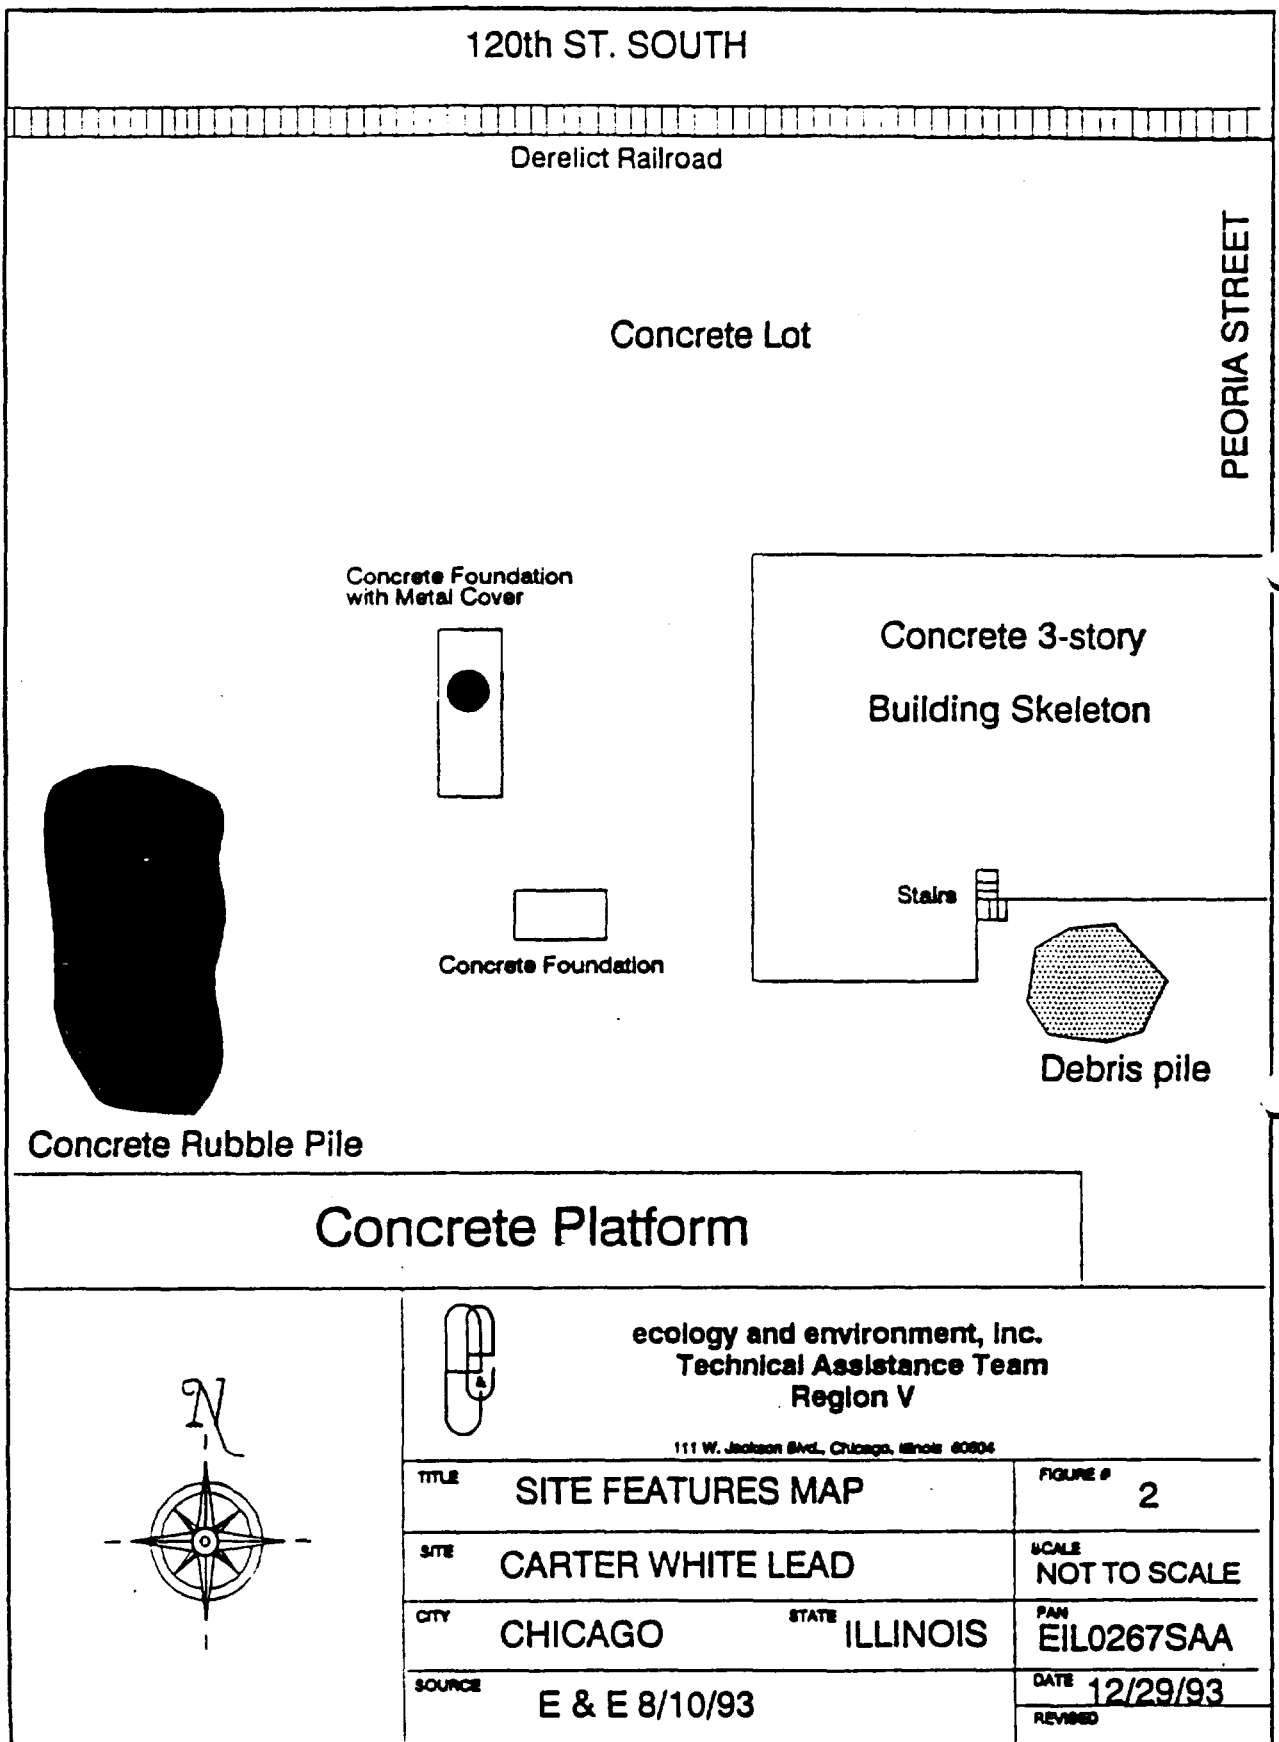
A general walk-through of the site was performed, and the site was photo-documented. Continuous air monitoring was performed throughout the walk-through using a HNu Photon-Ionizer. No on-site readings above a preliminary off-site background calibration were obtained. Also used was an MSA 261 explosimeter. No readings were obtained above background. The grounds surrounding the 3-story building frame, building foundations, and loading docks were covered by asphalt and concrete. Areas with the potential to have exposed lead-contaminated soils (i.e. not covered by asphalt or concrete), were not observed (see Figure 2). Several concrete foundations which indicate building foundations and loading docks are located south and west of the large 3-story concrete and steel building frame. A small refuse pile consisting of general household items and construction debris was evident directly south of the 3-story structure. Further south, a large pile of broken concrete was observed. No evidence of hazardous wastes was observed. Some limited vegetation was present, apparently growing through cracks in the asphalt and concrete. No evidence was visible of soil piles or exposed soils on-site.

The 130 cubic yards of soil containing greater than 5 mg/l EP Toxicity lead and approximately 140 cubic yards of soil containing greater than 1% lead were not apparent. U.S. EPA concluded that if these soils were present during the 1986 and 1987 removal activities, the areas of concern had subsequently been covered by asphalt and concrete. A decision was made by the personnel on-site not to disturb the asphalt and concrete surrounding the building foundations. If underlying soils surrounding and adjacent to the building foundations on the CWL site were covered by asphalt and concrete, this cover served as a barrier that would keep the lead-contaminated soils from becoming

Based upon the investigation by U.S. EPA and the TAT, no threats to health or the environment exist currently at the CWL site. It is recommended that no removal action take place at the CWL site.
